## CORRIDOR INFORMATION

## CRASH HISTORY (2018-2022)

## PROPOSED COUNTERMEASURES

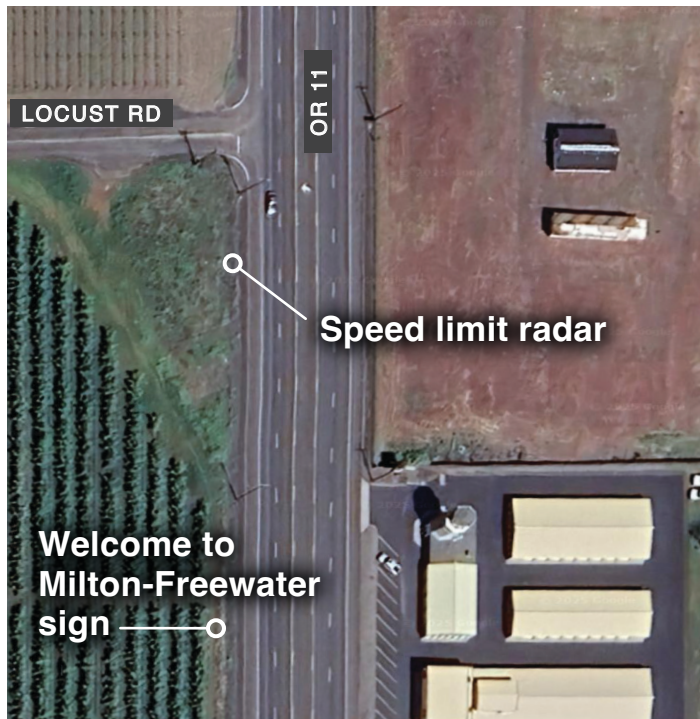
- Add **speed limit radar sign** to alert drivers of their speed relative to the posted speed.

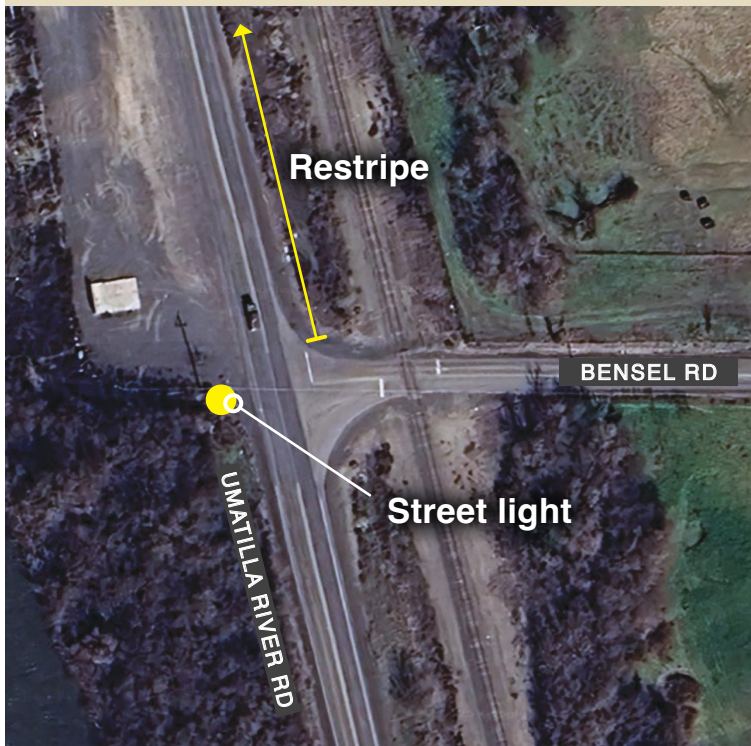
- Restripe roadway cross section north of Bensel Road to match the cross section south of Bensel Road, including fog lines and a narrow shoulder.

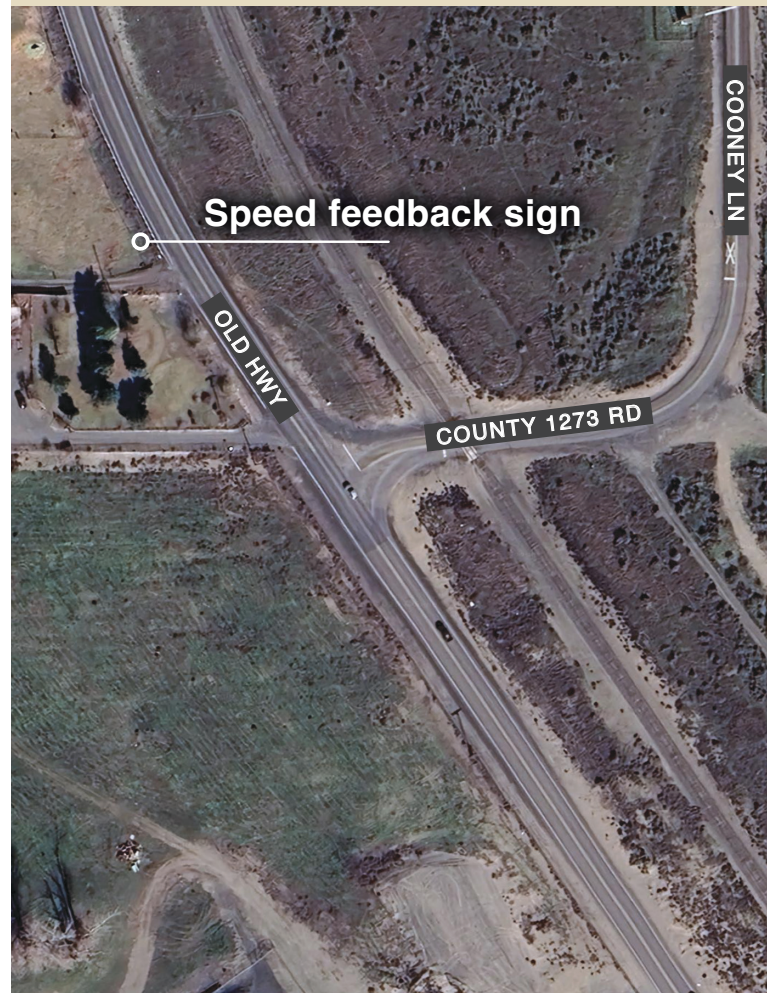
- Add speed feedback signage with the posted speed sign north of Cooney Lane where the posted speed reduces from 50 to 45 mph for southbound vehicles.

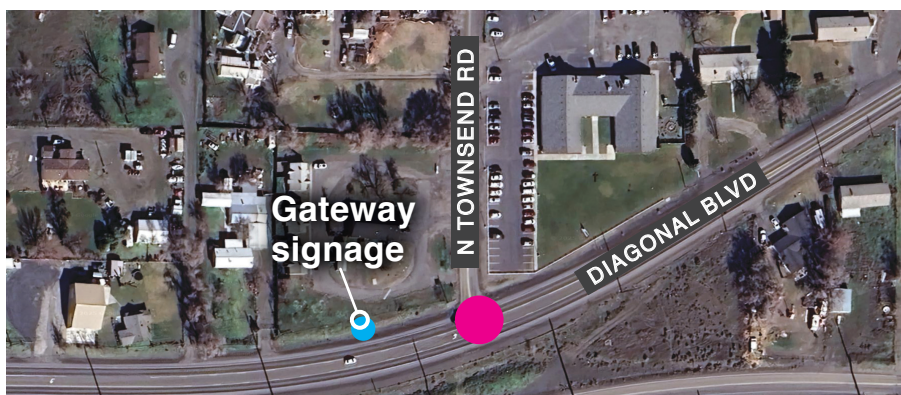
- A **roundabout** could serve as a City gateway design. Adding an additional "Welcome to Hermiston" sign helps differentiate the city limits.

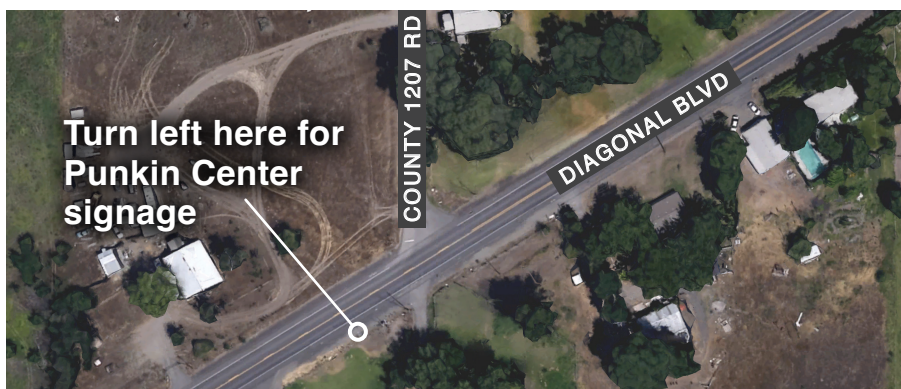
- Add **wayfinding signage** to get vehicles to turn earlier rather than crowding the busier turning locations.

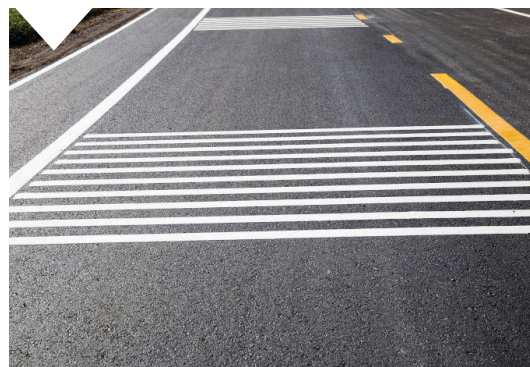
### Example of traverse rumble strips

- **Transverse rumble strips** (with warning signs and speed feedback signs) manage speeds and increase driver attentiveness by signifying an upcoming change in the roadway geometry. This application of transverse rumble strips requires approval from the ODOT State Traffic Engineer. Transverse rumble strips have been installed on eastbound Westland Road approaching the intersection with Bridge Road.

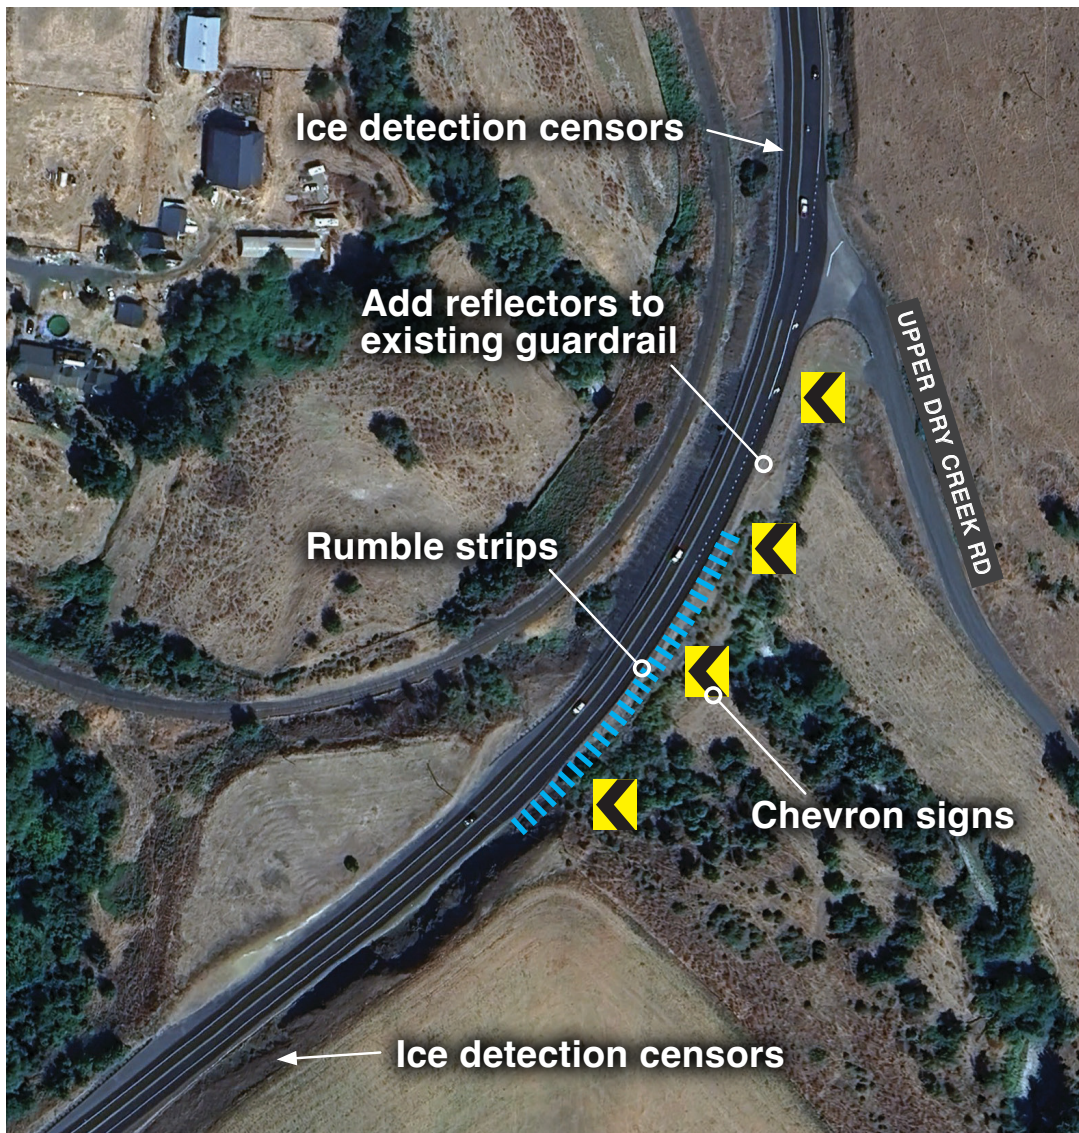
- **Chevrons and guardrail reflectors** also provide delineation and alert drivers of barrier location.
- **Ice detection sensors** paired with dynamic warning signs may be an effective application of ITS on segments with historic patterns of crashes during snowy or icy conditions.
